**Flood Control Project Maintenance  
Levee Inspections**

## Maintenance Issue Types Only, Levee Inspection Report By Mile - Fall 2016

### Reclamation District No. 2068 Yolano

Waterway	Bank	Unit Miles	Inspection Start/End	Inspector
Unit No. 01 Yolo Bypass	Right	5.48	09/22/2016 09/22/2016	Herman Phillips

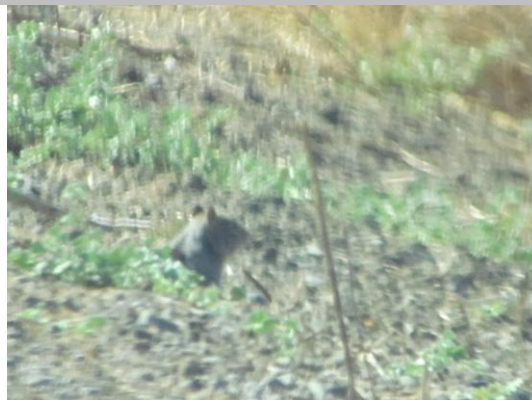
Photo 1 of 2 : FA\_2016\_RD2068\_193\_11\_20160926\_00003.jpg

LM Start	2.11	Rating **	M	Issue No.	11
LM End	2.46	Issue Type +	Ma	Location *	LS
Category	Earthen Levee			GPS Latitude/Longitude	
				Start	End
Item	Animal Control			38.378028 °	38.372862 °
				-121.693908 °	-121.693978 °
DWR ID	DWR_RD2068_01_f_2016_11				
Comment Code					
A1 : Exterminate rodents and backfill and compact or grout burrows.					
Inspector Comment					
There are active rodents in the area, several holes were seen but no bait stations observed on the slope where rodents were noted.

RD 2068 looking downstream landside slope from levee miles 2.11 -2.46.

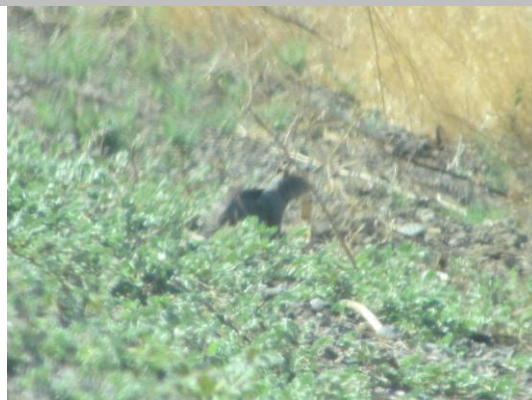
Photo 2 of 2 : FA\_2016\_RD2068\_193\_11\_20160926\_00004.jpg

LM Start	<b>2.11</b>	Rating **	M	Issue No.	<b>11 (cont)</b>
LM End	<b>2.46</b>	Issue Type +	Ma	Location *	LS

RD 2068 looking downstream landside slope from levee miles 2.11-2.46.

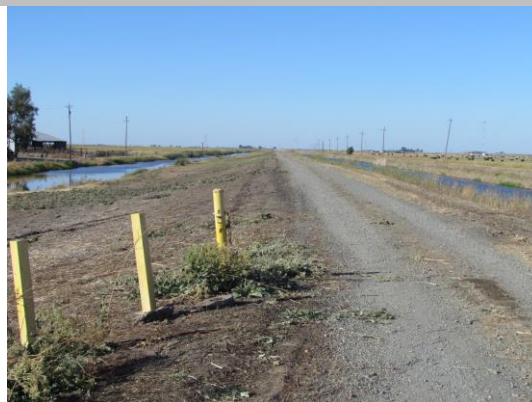
Photo 1 of 1 : FA\_2016\_RD2068\_194\_11\_20160926\_00007.jpg

LM Start	0.01	Rating **	A	Issue No.	11
LM End	2.73	Issue Type +	Ma	Location *	WS
Category	Earthen Levee			GPS Latitude/Longitude	
				Start	End
Item	Vegetation			38.358232 °	38.392895 °
				-121.740370 °	-121.720985 °
DWR ID	DWR_RD2068_02_f_2016_11				
Comment Code					
V1 : Control annual grass and weeds on the levee slopes and easements.					
Inspector Comment					
there is no unwanted vegetation along the waterside levee slope 0.01-2.73. The Maintaining Agency recently mowed the site.

RD 2068 looking downstream from levee mile 0.01-2.73.
